## EKRANOSOLS OF TORUŃ AIRFIELD

PRZEMYSŁAW CHARZYŃSKI  
RENATA BEDNAREK  
ŁUKASZ MENDYK  
MARCIN ŚWITONIAK  
ALEKSANDRA POKOJSKA-BURDZIEJ  
ANDRZEJ NOWAK

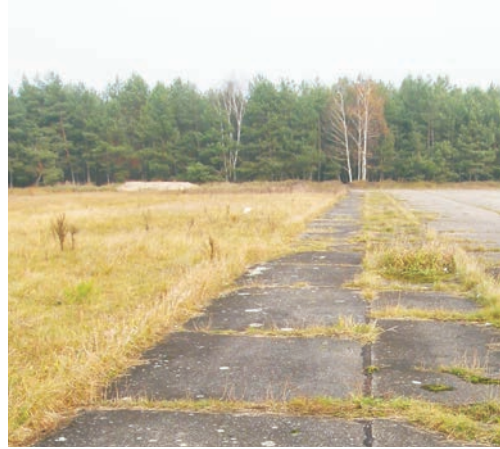
## Profile 1

**Ap - 0-18 cm:** human-disturbed, sand, dark greyish brown, weak granular structure, slightly moist, clear boundary.

**B/Cp - 18-55 cm:** human-disturbed, sand, very pale brown, single grain structure, slightly moist, clear boundary.

**A/Bp - 55-74 cm:** human-disturbed, sand, pale brown, weak granular/single grain structure, slightly moist, clear boundary,

**A/Cp - 74-94 cm:** human-disturbed, sand, pale brown, weak granular/single grain structure, slightly moist, insertion of organic matter enriched material, clear boundary.

**Ab - 94-103 cm:** sand, greyish brown, single grain structure, slightly moist, clear boundary.

**Bwb - 104-130 cm:** sand, light yellowish brown, single grain structure, slightly moist, gradual boundary.

**C - below 130 cm:** sand, very pale brown, single grain structure, slightly moist.

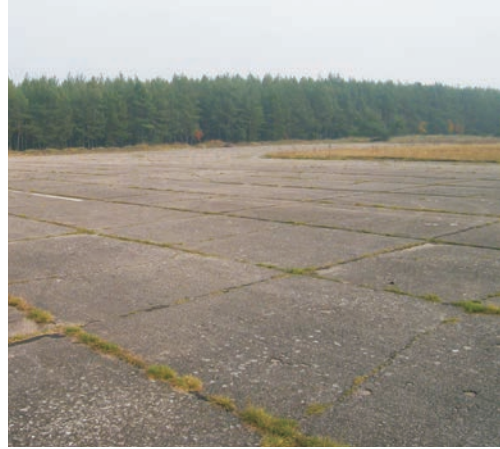
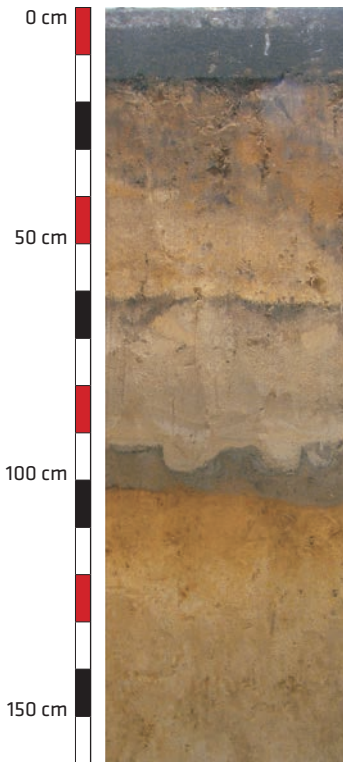
## Profile 2

**Concrete slab – 0-15 cm.**

**Ap1 – 15-20 cm:** sand, pale brown, weak granular structure, slightly moist, clear boundary.

**B/Cp – 20-60 cm:** sand, very pale brown, weak granular structure, slightly moist, clear boundary.

**Ap2 – 60-63 cm:** sand, very dark grey, weak granular structure, slightly moist, clear boundary.

**C – 63-95 cm:** sand, pale brown, single grain structure, slightly moist, clear boundary.

**Ab – 95-102 cm:** sand, light brownish grey, single grain structure, slightly moist, clear boundary.

**Bwb – 102-120 cm:** sand, light yellowish brown, single grain structure, slightly moist, clear boundary.

**C – below 120 cm:** sand, very pale brown, single grain structure, slightly moist.
