# Optical Coherence Tomography (OCT) for examination of artworks

M. Iwanicka, M. Sylwestrzak, P. Targowski

Nicolaus Copernicus University, Torun, Poland

Published in: Bastidas D., Cano E. (eds) Advanced Characterization Techniques, Diagnostic Tools and Evaluation Methods in Heritage Science. Springer, Cham, 2018, pp 49-59, doi: 10.1007/978-3-319-75316-4, Authors'version

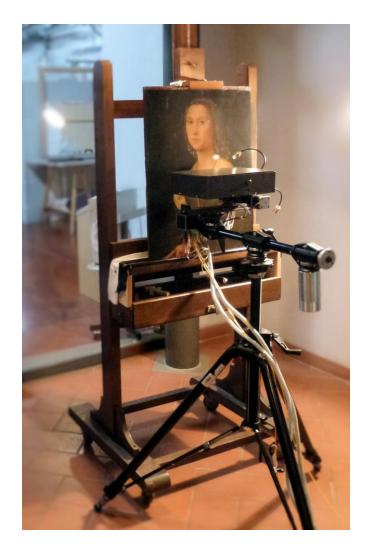
**Figure 1.** An in-situ examination of Raphael's *La Muta* in 2014 at Opficio delle Piere Dure in Florence, Italy with the portable OCT tomograph constructed at Nicolaus Copernicus University in Toruń

For examination of the objects presented in this study we have used the system designed and built especially for the examination of cultural heritage objects under 7FP Charisma project at N. Copernicus University in Torun, Poland. It is a Fourier domain OCT instrument with a spectrograph used as a detector. As a light source the instrument utilises superluminescent multi-diode emitting in band 770-970 nm providing the beam intensity up to 800 µW at object. This irradiation level is considered non-invasive even for light-sensitive materials. In practice, the ability to differentiate thin layers is denoted by the axial (in-depth) resolution, which equals ca 2.2 µm (in material of refractive index equal to about 1.5). Lateral resolution (the ability to differentiate between structures occurring close to each other in lateral plane) is about 13 µm. These features make our instrument especially well-suited for the examination of thin-layered structures, such as easel paintings. The axial imaging range is 1.7 mm and sensitivity 98 dB. The distance to the examined object from the most protruding element of the device is 43 mm and the structural information from the area up to 17×17 mm<sup>2</sup> may be acquired in one measurement. Data collection time for one 2D cross-section (B-scan) is 0.15 s. Two standard video cameras enable the precise documentation of the position of examined area at the object.

Additionally, OCT provides better representativeness of results (in comparison to traditional, invasive sampling methods) due to the fast data collection and no need for any special object preparation (Fig. 1). Usually sampling is permitted only to spots where some damage has occurred previously or, in case of easel paintings, areas of lesser visual importance. OCT provides structural information from the spots which cannot be sampled, and, in cases when sampling is still required, helps to limit it to few representative spots.

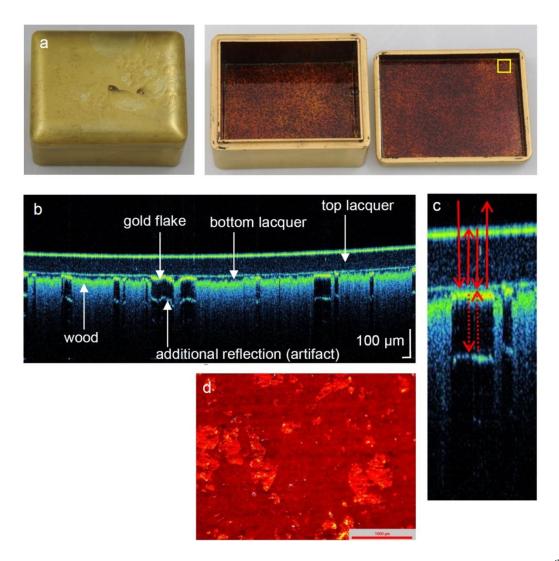
**Figure 2.** (a) Gilded wooden box decorated with depictions of quails and herbs, Japan, 19<sup>th</sup>/20<sup>th</sup> c., District Museum in Torun, inv. MT/DW/392. Inside of the box and the lid is decorated in nashiji technique. (b) OCT tomogram and (c) tomogram fragment, from the lid (see text for explanation). (d) microscopic image of the inside of the lid.

In many decorative techniques semi-transparent paints or lacquers were used to obtain three dimensional visual effects. For instance, Japanese *nashiji* technique (imitated in 18<sup>th</sup>-19<sup>th</sup> c. Europe under the name of *aventurine lacquer*, or *moraqqash* in Islamic art) is based on embedding metal (usually gold) flakes in-between two layers of lacquers [16, 17]. OCT gives direct insight into the technology of making of such an object (Fig. 2).

Top layer of lacquer is easily recognizable and its thickness (under 100  $\mu$ m) and magnificent homogeneity may be assessed. Bottom lacquer layer (onto which the gold flakes had been sprinkled) despite of being relatively thin (ca 15  $\mu$ m) makes a smooth surface over the roughness of wood. Wooden support is non-transparent to OCT imaging, however since it scatters the probing light, time of returning of the signal to the OCT instrument varies, which creates the effect of 'fading' of OCT signal in the tomogram. Gold flakes are basically also non-transparent to the infrared radiation, however since they reflect the probing beam strongly instead of scattering it, due to multiple reflection of light between the gold and the surface of the upper lacquer an artificial 'interface' is visible beneath the gold flake (Fig 2c).

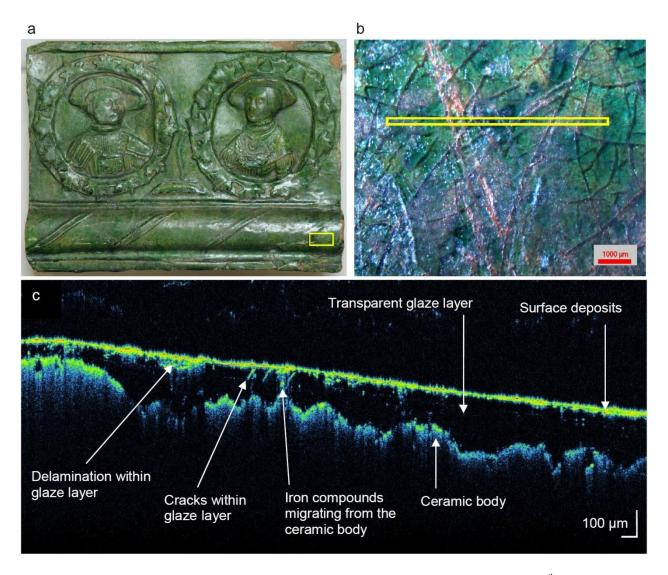
**Figure 3.** (a) Ceramic tile, engobe, lead-based, copper-tinted glaze, Torun, 16<sup>th</sup> c.?, District Museum in Torun, inv. MT/ZK/1065, yellow rectangle marks the location of the microscopic image. (b) Microscopic image of the scanned area, yellow line marks location of the presented tomogram. (c) OCT tomogram

Apart from providing knowledge on the technology and layers' build-up OCT can be a useful tool for fast assessing of the artwork's state of preservation. Revealing of many destruction phenomena within the subsurface layers is possible provided that the materials are semi-transparent to near infrared radiation. Transparent and semi-transparent glazes on ceramic objects (Fig. 3c) may be investigated in terms of its thickness and production faults (like air bubbles). Also time-related cracks and delaminations are easily recognised due to the large leap of refractive index between air and lead glass which constitutes the glaze. Semi-transparent dirt deposits on the surface (right-hand side of the tomogram in Fig. 3c) scatter and partially absorb the OCT beam, but, in this case, do not hinder the visibility of the ceramic body underneath the glaze. It is worth to note that OCT can be of use in planning conservation-restoration of such artefacts, through both identification of fragile spots and direct monitoring of the cleaning treatments [18].

More subtle phenomena like, for instance, migration of iron compounds from the ceramic body to the bulk of the glaze (through fine cracks) can be understood thanks to the precise localisation of the examined spot, direct comparison of the tomogram with a microscopic photograph, and, last, but not least, taking into consideration the history of the object. In this case, the investigated tile was found among many other similar items on the archaeological site of the Teutonic Order Castle in Toruń during the excavation works in 1958-66. The castle ruins had been used as a wasteyard for the whole old city area since the middle 15<sup>th</sup> c., when the castle was demolished, up to late 19<sup>th</sup> century, the ceramic objects were therefore subjected to contact with water, earth and mineral depositions.

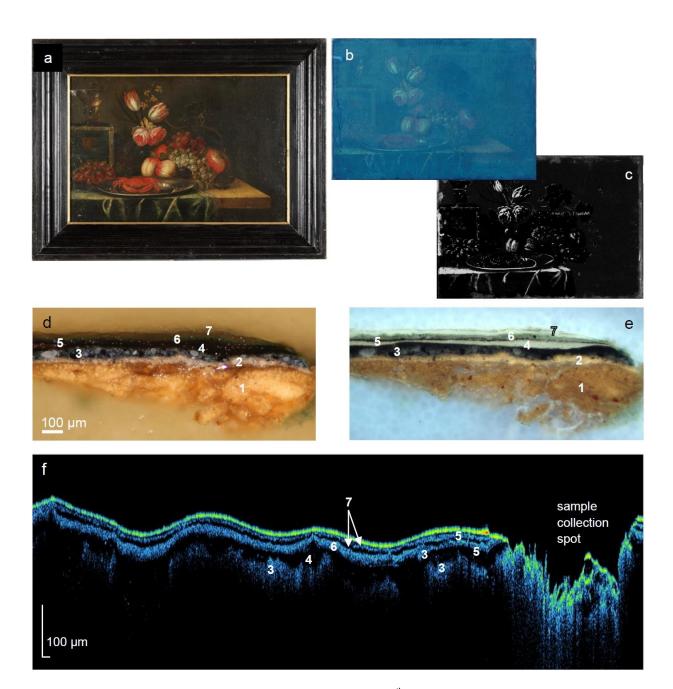
**Figure 4.** Still life with a crab, Jacob van Walscapelle, 17<sup>th</sup> c., oil on canvas, 41x59 cm, Museum of Warmia and Mazury in Olsztyn. (a) Visible light; (b) UV-induced fluorescence; (c) macro-XRF scan of the whole picture showing distribution of zinc; (d,e) microphotographs of a cross-section of a sample collected from the area of a green tablecloth near the lower edge of the painting: visible light (d) and UV-induced fluorescence (e), magnification 100x. Description of layers: 1. ground layer, 2. underpaint, 3. blue paint layer, 4. primary varnish, 5. superficial dirt, 6. green paint layer (secondary); 7. two varnish layers. (f) OCT tomogram from the perimeter of sample collection spot, the numbers correspond to the layers identified in the sample (Fig. 4 d,e)

In some cases optical coherence tomography may also help in authentication of the painting, usually as a complementary tool for some spectroscopic analyses. An interesting example of such an approach is resolving of the sequence of layers in the 17<sup>th</sup> c. Dutch still life painting, signed J. Walscapele (Fig. 4a). The painting had been in the past subjected to many renovation/restoration treatments. Their effects were obscured by the already aged, yellowed and deteriorated varnish of strong UV-induced fluorescence (Fig. 4b). However, macro-XRF scanning revealed the presence of pigments not used earlier than 19<sup>th</sup> c.: of zinc and barium white in all the highlights (Fig. 4c, 5e) as well as chromium green (in the area of the tablecloth). Apart from the abovementioned areas the other pigments identified were typical for the 17<sup>th</sup> c.: calcium based ground, lead white, vermillion, copper based green, ochres and umbers [19].

OCT data were collected in 20 areas which were showing the presence of zinc/chromium. In most of the examined spots a highly scattering, yet infrared-permeable layer was found between the varnishes. It seemed highly probable that it was a 19<sup>th</sup> c. overpainting. To confirm this hypothesis the microsample (Fig. 4d,e) was collected from the lower edge of the composition (from a perimeter of a paint-loss) as a reference for interpretation of the OCT data. The observation of the cross-section in visible light and under ultraviolet illumination (Fig. 4 d,e) confirmed that the secondary paint layer, in this case – dark green (marked 6 in Fig. 4 d, e, f) is located between the varnishes.

Also it is a good example of how some layers differ in the photograph and OCT. Two varnish layers on top (7 in Fig. 4 d, e, f) are well discernible in OCT (in all examined

spots), whereas they are barely visible at the edge of the sample. Such problems may stem from various causes. First of all, OCT is sensitive to leap of refraction index between the layers as well as the presence of dirt, which acts as a light-scattering agent; in such cases the layers are well discernible in OCT tomograms. However, if they are too thin (under ca 3 microns) they will not be seen as separate ones. On the other hand, also the technique of preparation of cross-samples has some drawbacks – e.g. some varnishes are easily dissolvable in embedding resin or, if they are brittle and therefore susceptible to delamination during sampling and embedding.

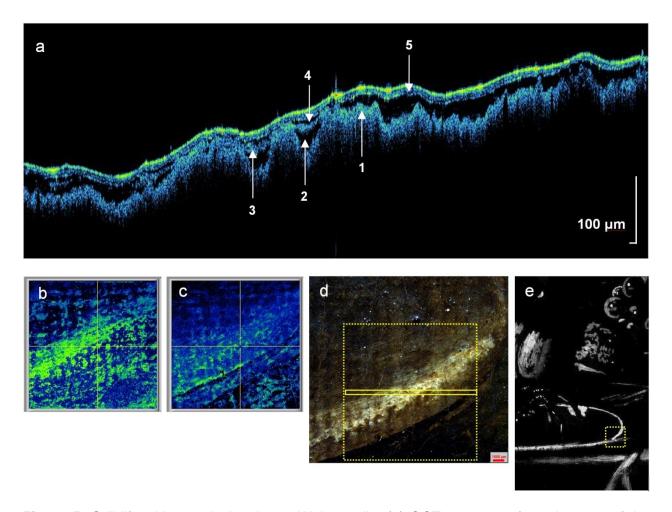
**Figure 5.** Still life with a crab, Jacob van Walscapelle. (a) OCT tomogram from the area of the rim of the silver plate. Description of layers: 1. primary paint layer, 2. varnish, 3. zinc-rich (secondary) paint layer, 4. varnish, 5. two varnish layers; (b,c) coherence gate images – b:19  $\mu$ m gate depth, 7  $\mu$ m gate width, c: 66  $\mu$ m gate depth, 7  $\mu$ m gate width; (d) macrophotography of the

examined area, with dashed square marking the scanned area and yellow line marking the location of the tomogram; (e) macro-XRF scan (fragment) showing distribution of zinc, dashed square mark the scanned area

A common approach is to use the information obtained through minimal sampling to interpret the results of multiple non-invasive analyses. In case of the Walscapelle painting it proved feasible since the good state of preservation of the painting in its central part had excluded further sampling. However, the OCT data collected in zinc-rich areas of highlights (Fig. 5) enabled to precisely locate the zinc-containing layer (3 in Fig. 5a, bright green colour in Fig. 5b) within the whole painting's structure: it is lying between the varnish layers. This conclusion was additionally confirmed by the gate imaging technique (Fig. 5 b, c). The highlight on the rim of the silver plate (Fig. 5 d) consists of a paint layer lying 19 µm beneath the surface of the painting (Fig. 5 b), on top of varnish layer. At the depth of the primary paint layer, 66 µm under the surface (Fig. 5 c) there is no paint layer in this shape. To conclude, in the case of *Still life with a crab* the synergistic use of structure analysis (by OCT) and surface-mapping (by means of MA-XRF) enabled resolving both the range, amount and time of renovations of the painting.
